A0202-10-1

## PROJECT REPORT

**on the comparative evaluation of  
asphalt layer characteristics with and  
without hydrated lime modification**

**Test track B62 Lackendorf**

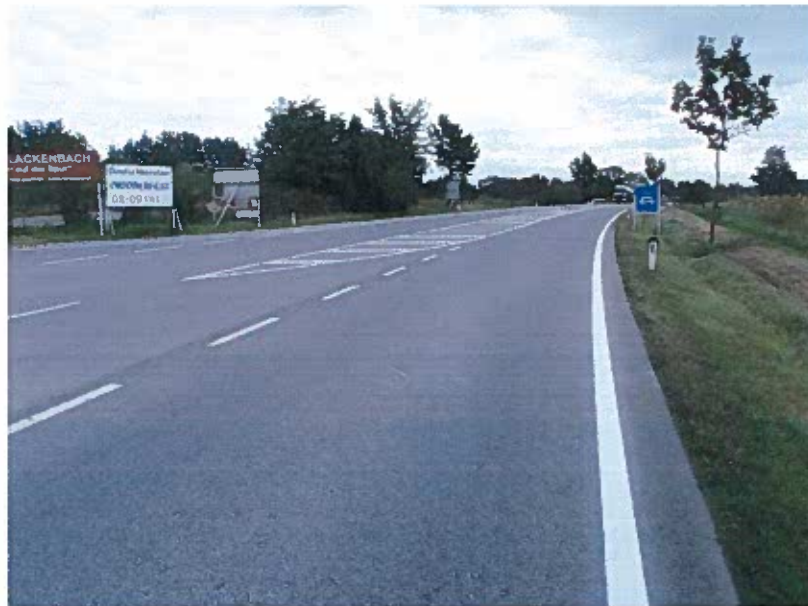
Evidently the asphalt surface course modified with hydrated lime does not differ from the one assembled with polymer-modified bitumen. Both asphalt layers do not show fretting or other surface damages like crack formation. The following pictures document the status display of the asphalt surface course produced with hydrated lime as additive.

Picture 1: Overview test track with hydrated lime

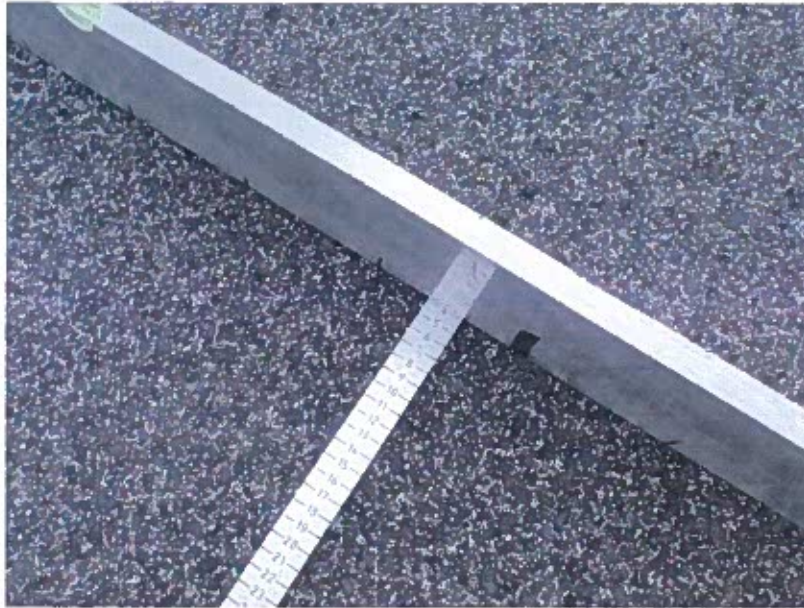
Picture 2: Rut measurement at profile no. 2, km 3,613

The rut measurement was effected over the whole roadway width by use of the measuring device "Planum" and a 2 m-rod according to RVS 11.06.62.

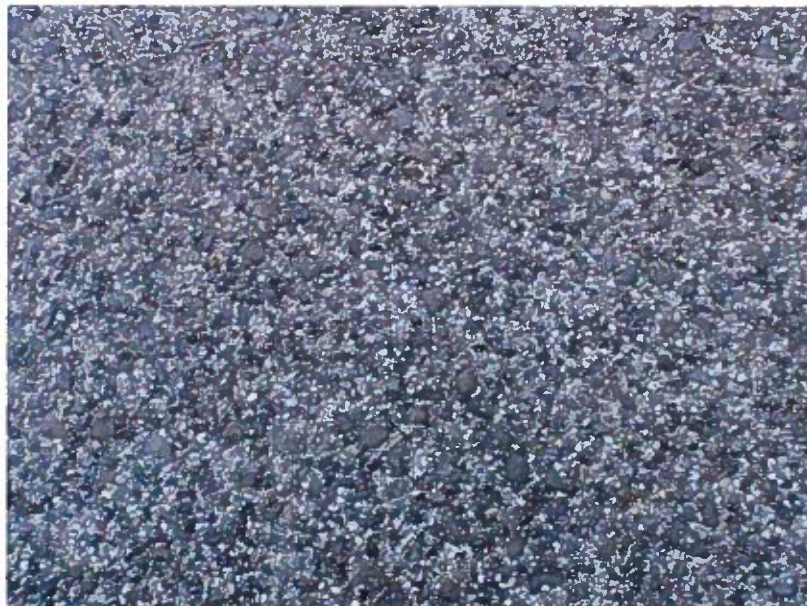
Picture 3: Surface texture of the asphalt surface course with hydrated lime

The surface status display of both the test track and the comparative track are free from crack formation and other surface damages. Visually no difference between the two asphalt surface course systems can be identified.

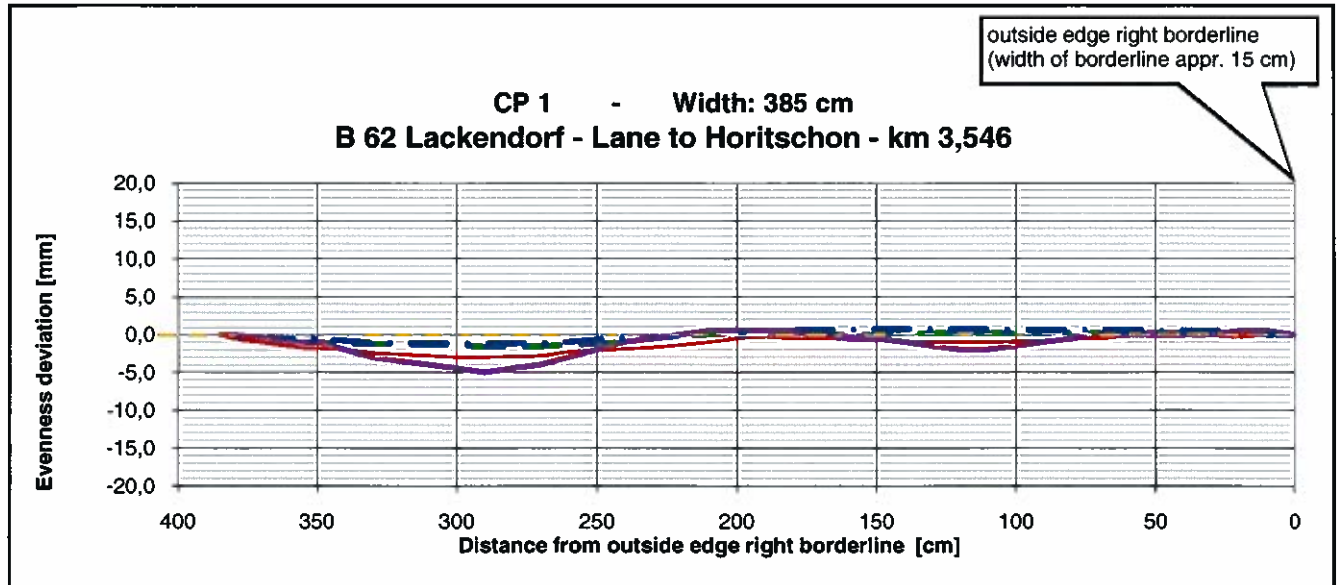
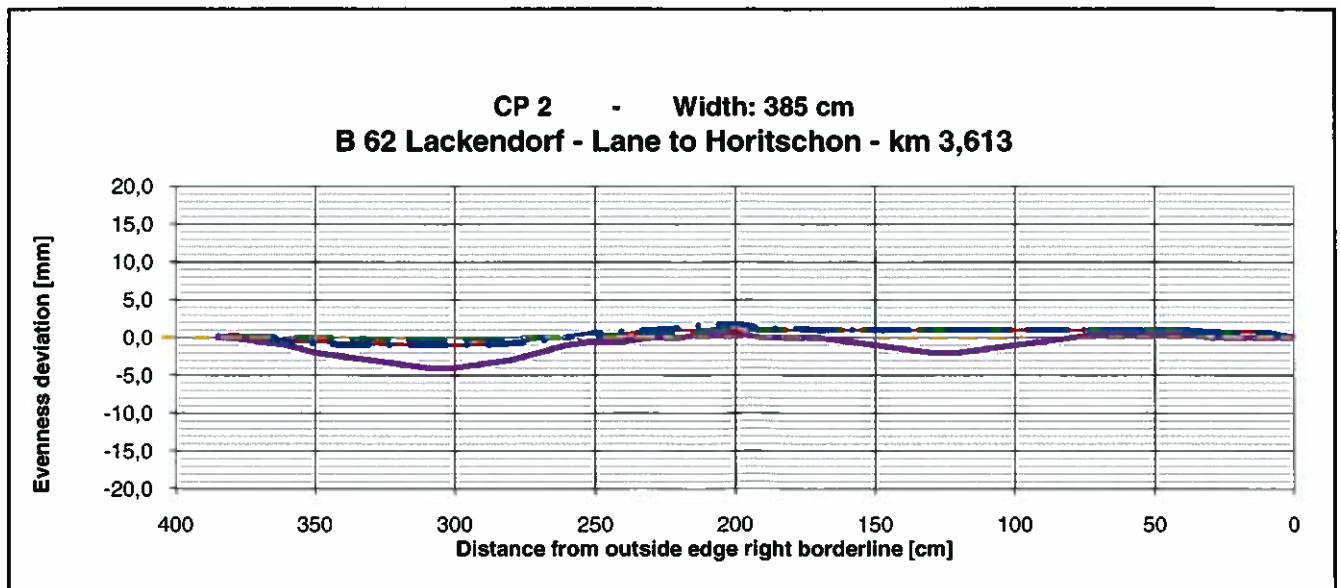
## Asphalt modified with hydrated lime

In course of the last measurement in autumn 2010 the test track (paving grade bitumen and hydrated lime) shows slightly increased deformation than the comparative track (polymer-modified bitumen). The differences observed on the roads meet the conclusions from the type testings. After a service life of six years the test track shows an average rut depth of 4 mm, compared to an average rut depth of 2 mm on the comparative track; in general both are on a low level.

Cross-evenness with the measurement device "Planum"

Cross profiles 1, 2, 7 and 8 (paving grade bitumen with hydrated lime)

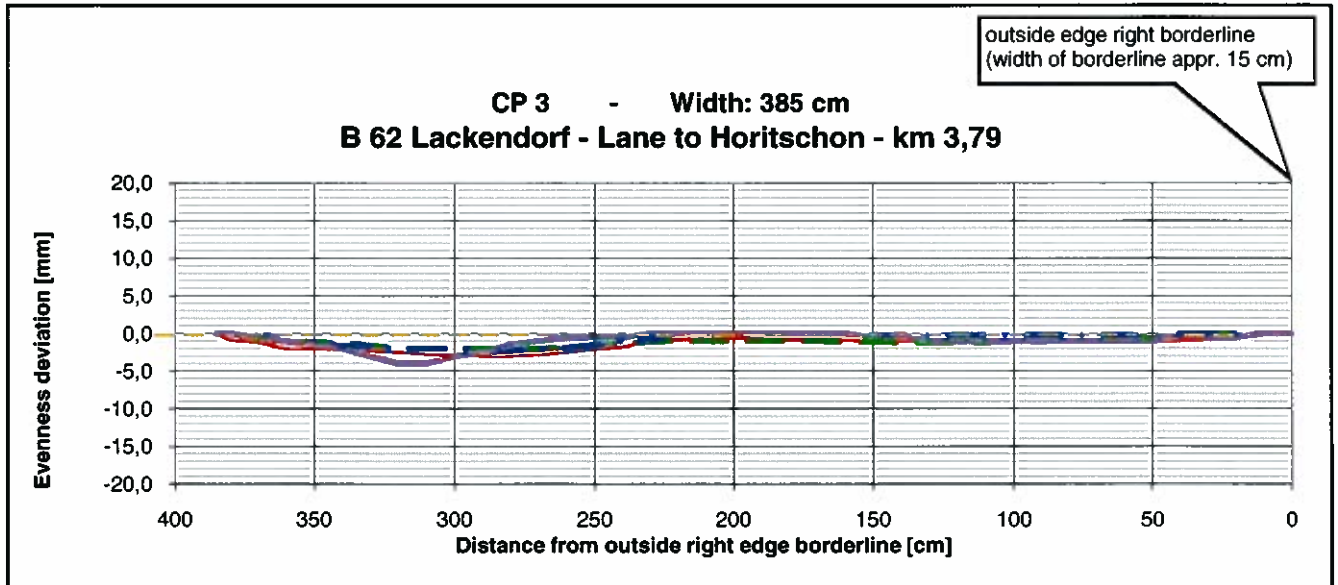
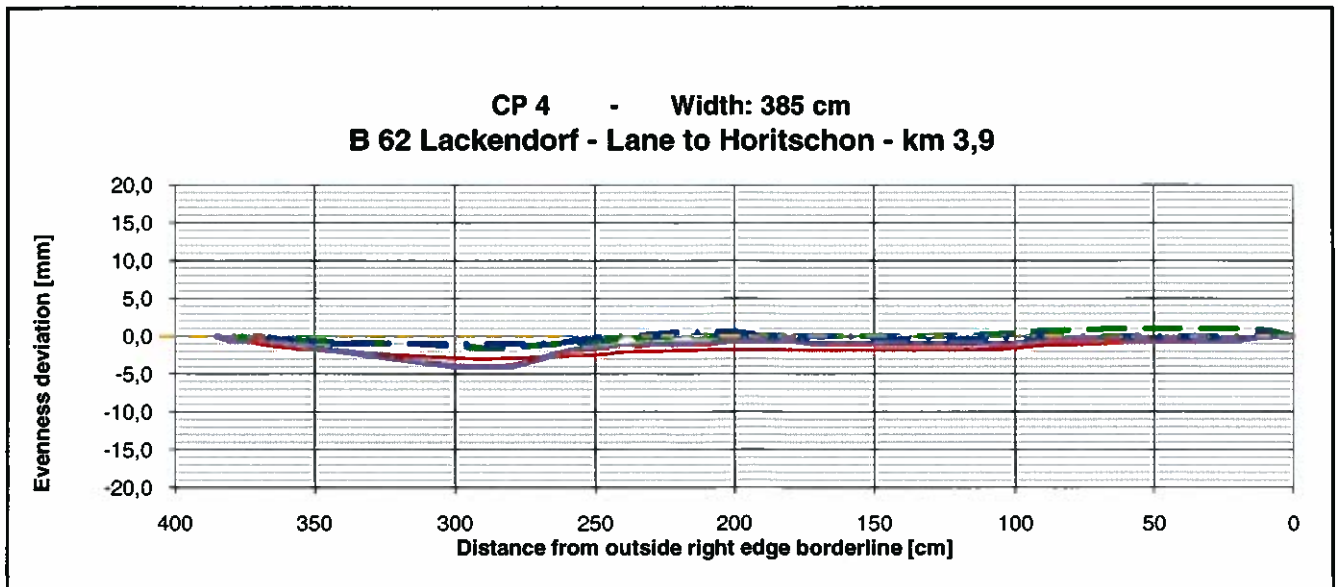
## Asphalt with polymer-modified bitumen

Cross profiles 3, 4, 5 and 6 (polymer-modified bitumen)
